**NASA Contractor Report 158969**

**ASSESSMENT OF STATE-OF-THE-ART  
OF IN-SERVICE INSPECTION METHODS  
FOR GRAPHITE EPOXY COMPOSITE  
STRUCTURES ON COMMERCIAL  
TRANSPORT AIRCRAFT**

**Boeing Commercial Airplane Company  
Seattle, Washington**

**Contract NAS 1-15304  
January 1979**

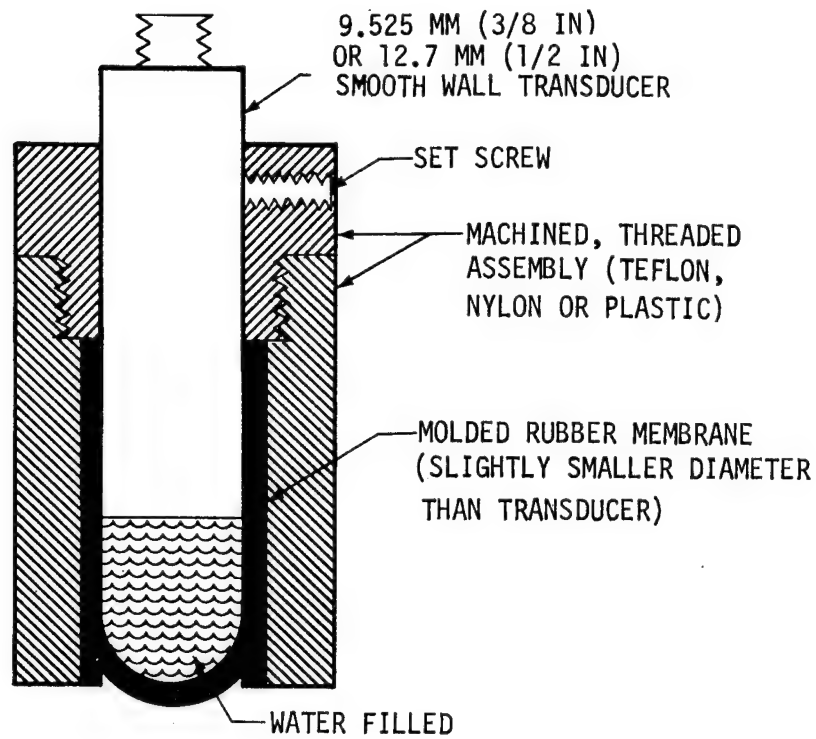
- o Standard ultrasonic test instrument equipped with a high-resolution pulser-receiver unit for 5, 10, and 15 MHz transducers.
- o One each 5, 10, and 15 MHz high-resolution contact search units.
- o One each 5, 10, and 15 MHz transducers adaptable to angle beam shoes.
- o Angle beam shoes.
- o Couplant: oil, grease, commercial couplant. Also, water bubblers, squirters, and encapsulated water standoffs have been used. The latter is illustrated in figure 1.

FIGURE 1. STAND-OFF SEARCH UNIT

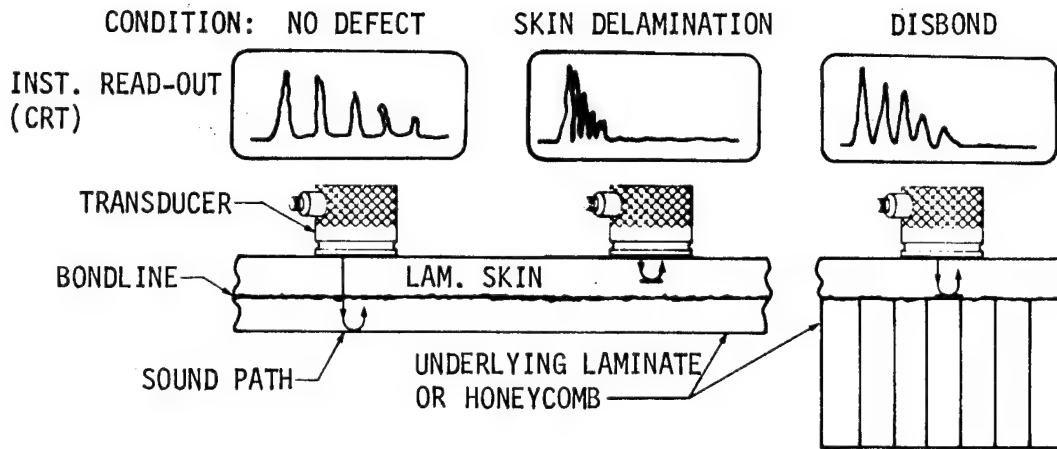
Two methods are described--the straight beam method and the angle beam method. Both are effective in detecting delaminations in the laminated composite skin and delaminations or disbonds at the skin-to-underlying structure interface. The angle beam method is applicable only to metal honeycomb. (It is unlikely that nonmetallic honeycomb will support sufficient sound transmission levels.) The straight beam method is applicable both to skin-to-honeycomb and skin-to-underlying laminate bonds. The two methods are illustrated in figures 2 and 3.

FIGURE 2. STRAIGHT BEAM TECHNIQUE

Using applicable instrument setup instructions and reference standards, verify instrument sensitivity with reference standard defects. It may be necessary to vary search unit assemblies using plastic shoes or encapsulated water standoff devices and various shoe angles for the angle beam method. Only certain frequencies or specific transducers may be usable on the structure and defect combination under investigation.

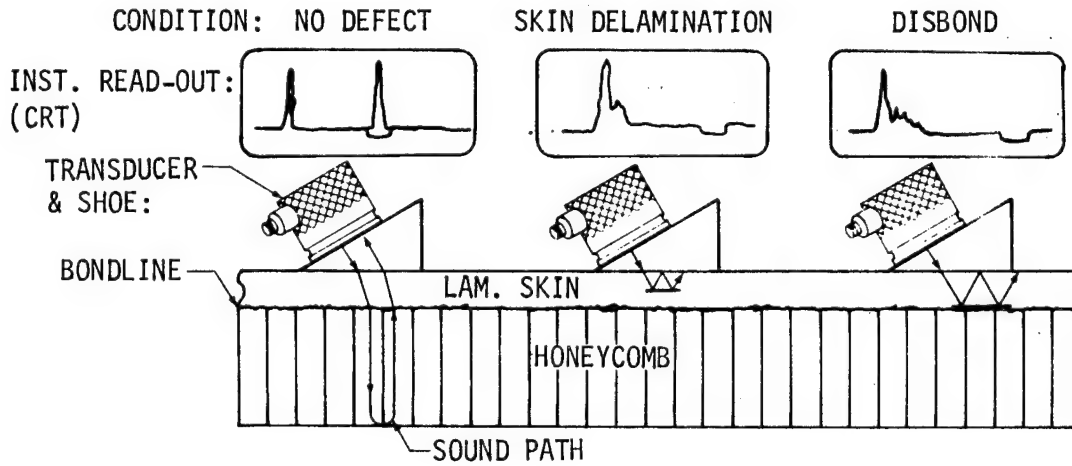
FIGURE 3. ANGLE BEAM TECHNIQUE

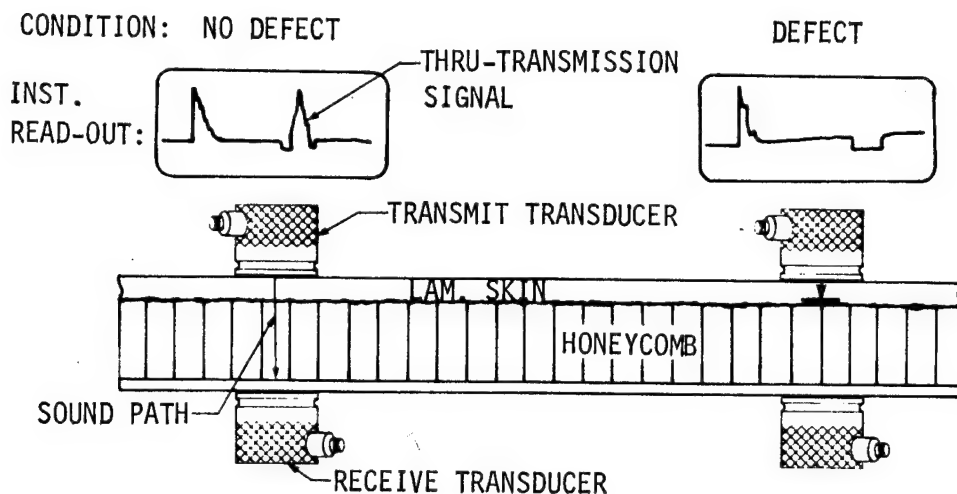
Ultrasonic pulses are generated by a "transmit" transducer coupled by water bath, water column to the part surface, or by direct contact with the part surface. The ultrasonic pulses enter the part and travel internally through the part and are detected by a "receive" transducer on the opposite side of the part also coupled to the part in the same manner as the "transmit" transducer. Detectable defects are those that block or reduce sound transmission seen as a loss or reduction in signal amplitude on the instrument readout (see fig. 4).

The through-transmission technique is predominantly used to inspect parts prior to installation on an airplane or after removal from an in-service airplane. With the part removed, it can be submerged in water or placed in a holding device for inspection by water column search units. With this setup, transducers do not contact the part surface and mechanical scanning with "C" scan recording is usually performed over the entire part. Defects are detected as anomalies on the "C" scan recording. However, this technique can also be used on installed parts using one of two methods.

FIGURE 4. THRU-TRANSMISSION TECHNIQUE

One of these is to manually place one of the transducers in direct contact with the part (using a couplant) and position the other transducer over the opposite surface to obtain a maximum through-transmission signal. This is repeated until the area of interest has been covered. The other method uses a yoke assembly to hold both transducers in constant alignment while scanning the transducers over the area of interest. These methods have been used to inspect limited areas of a given part.

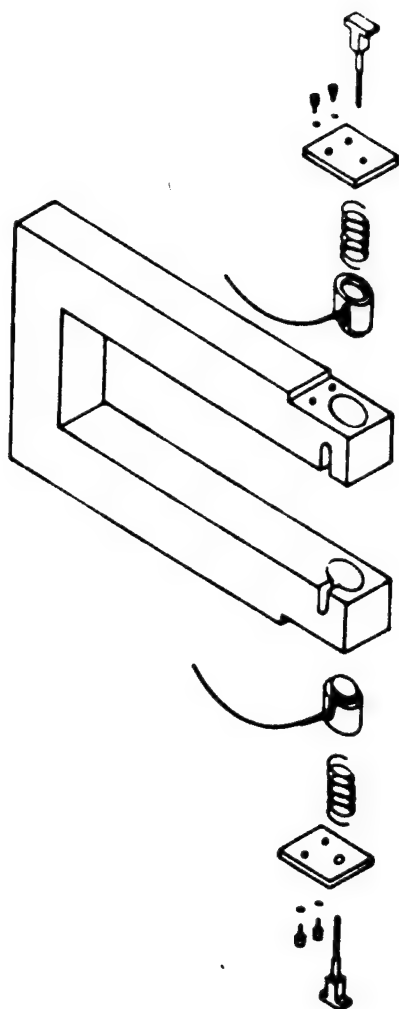
FIGURE 5. YOKE FOR THRU-TRANSMISSION INSPECTION \* \*(FROM "S-3A GRAPHITE/EPOXY SPOILER DEVELOPMENT PROGRAM, VOL II" JULY 1975, E.G.BLOSSER, ET AL.)

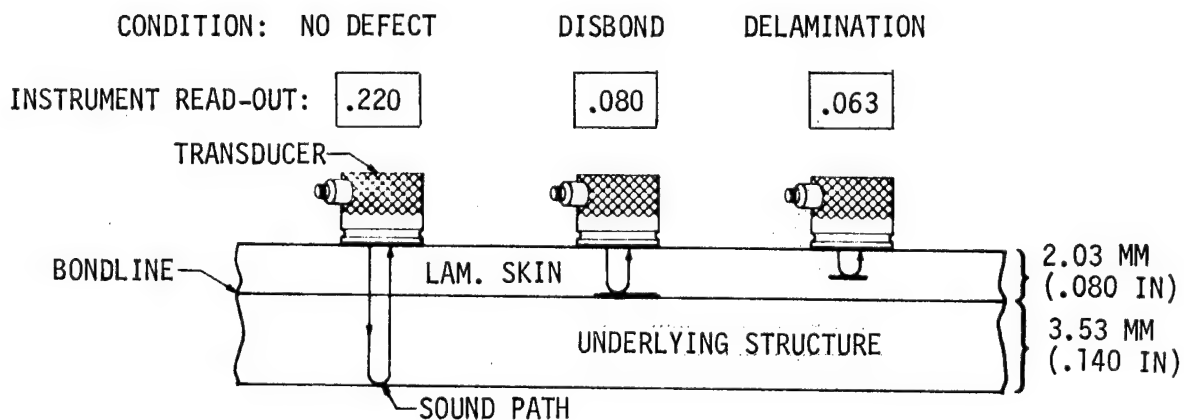
This method uses the pulse-echo principle wherein a transducer in contact, through a couplant, with the part surface generates a pulse that travels to the opposite surface of the laminated skin, echoes from this surface, and returns to the transducer. The time interval from pulse initiation to its return to the transducer is measured electronically and presented as the part thickness on a digital readout. This method detects delaminations in a laminate and may detect disbonds if the skin-to-underlying structure bond permits the pulse to pass into the underlying structure. It is illustrated in figure 6.

FIGURE 6. DIGITAL THICKNESS GAGE METHOD

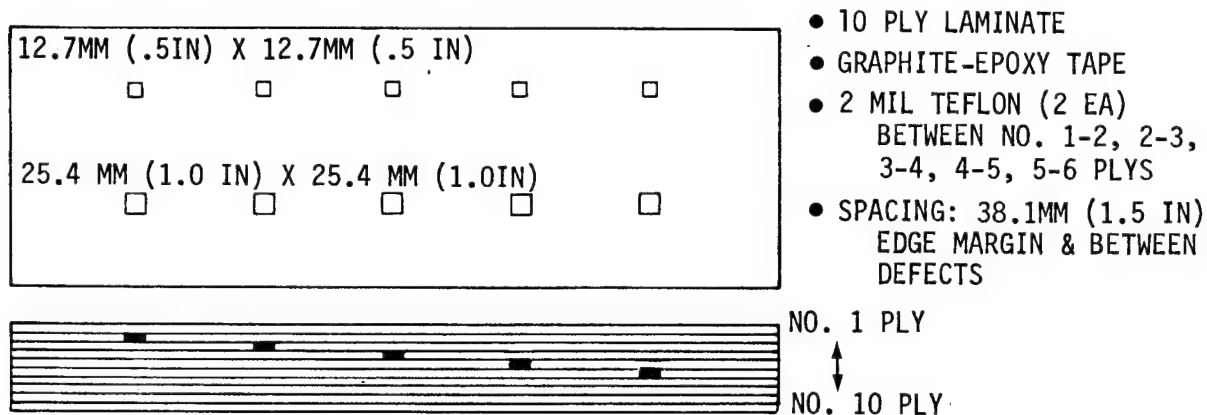
These are suitable for standardization of ultrasonic pulse-echo and through-transmission, bond test, and validation of tap test methods. They are fabricated by placing Teflon tape, mylar-covered porous filter material, Tedlar, precured adhesive, or prepreg tape in the bondline and between plies of a laminated part. The size is determined by the defect allowables criteria and shape may be either round or square. Figure 7 is typical. Step wedge thickness standards are illustrated in figure 8.

FIGURE 7. TYPICAL GRAPHITE-EPOXY DELAMINATION AND DISBOND REFERENCE STANDARD

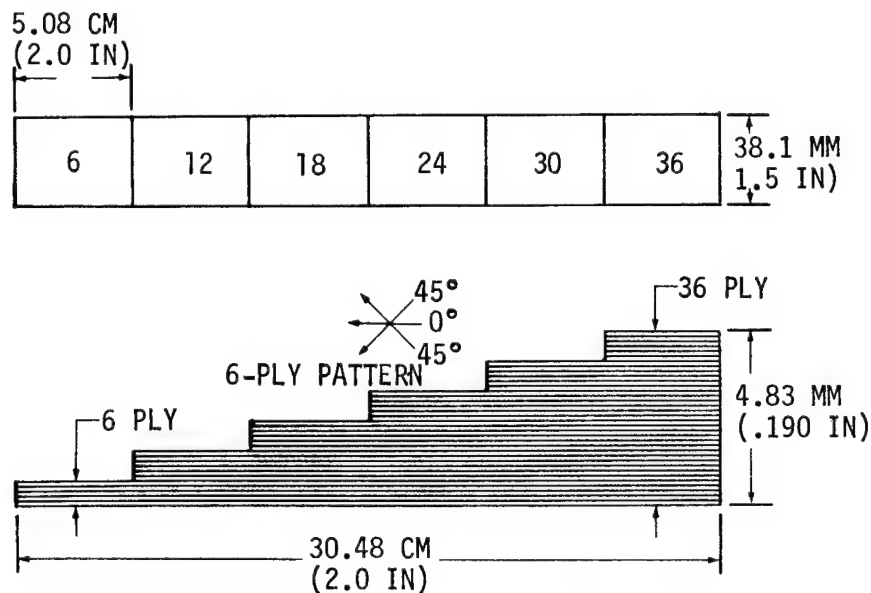
FIGURE 8. STEP-WEDGE THICKNESS REFERENCE STANDARD

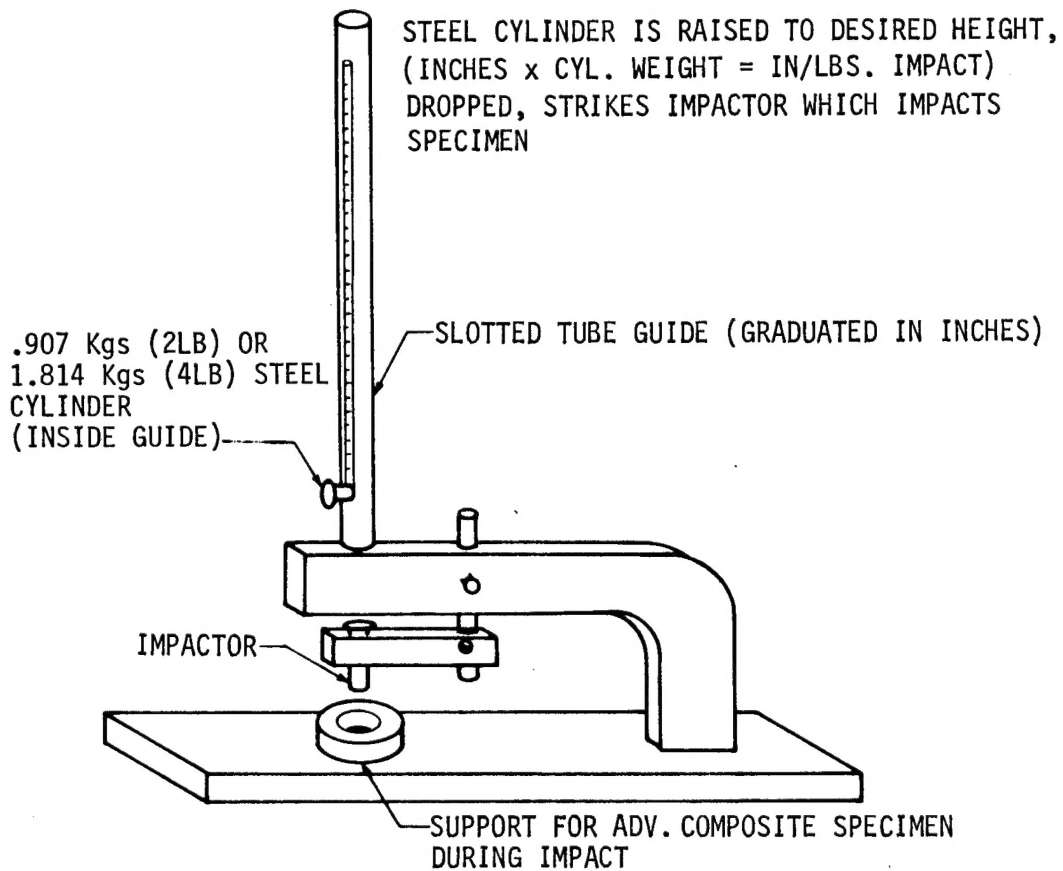
Impact Damage: This is created in the laminated skin member by impact of a blunt object with the test standard surface. A typical method is illustrated in figure 9. Impact defects in the reference specimen should range in severity up to visible damage. The nonvisible defects are used to verify sensitivity of ultrasonic, bond tester, and tap test methods.

FIGURE 9. METHOD TO ACCOMPLISH CONTROLLED IMPACT DAMAGE
